Fence Option C

Perth and Kinross Council are proposing to improve your local play area.

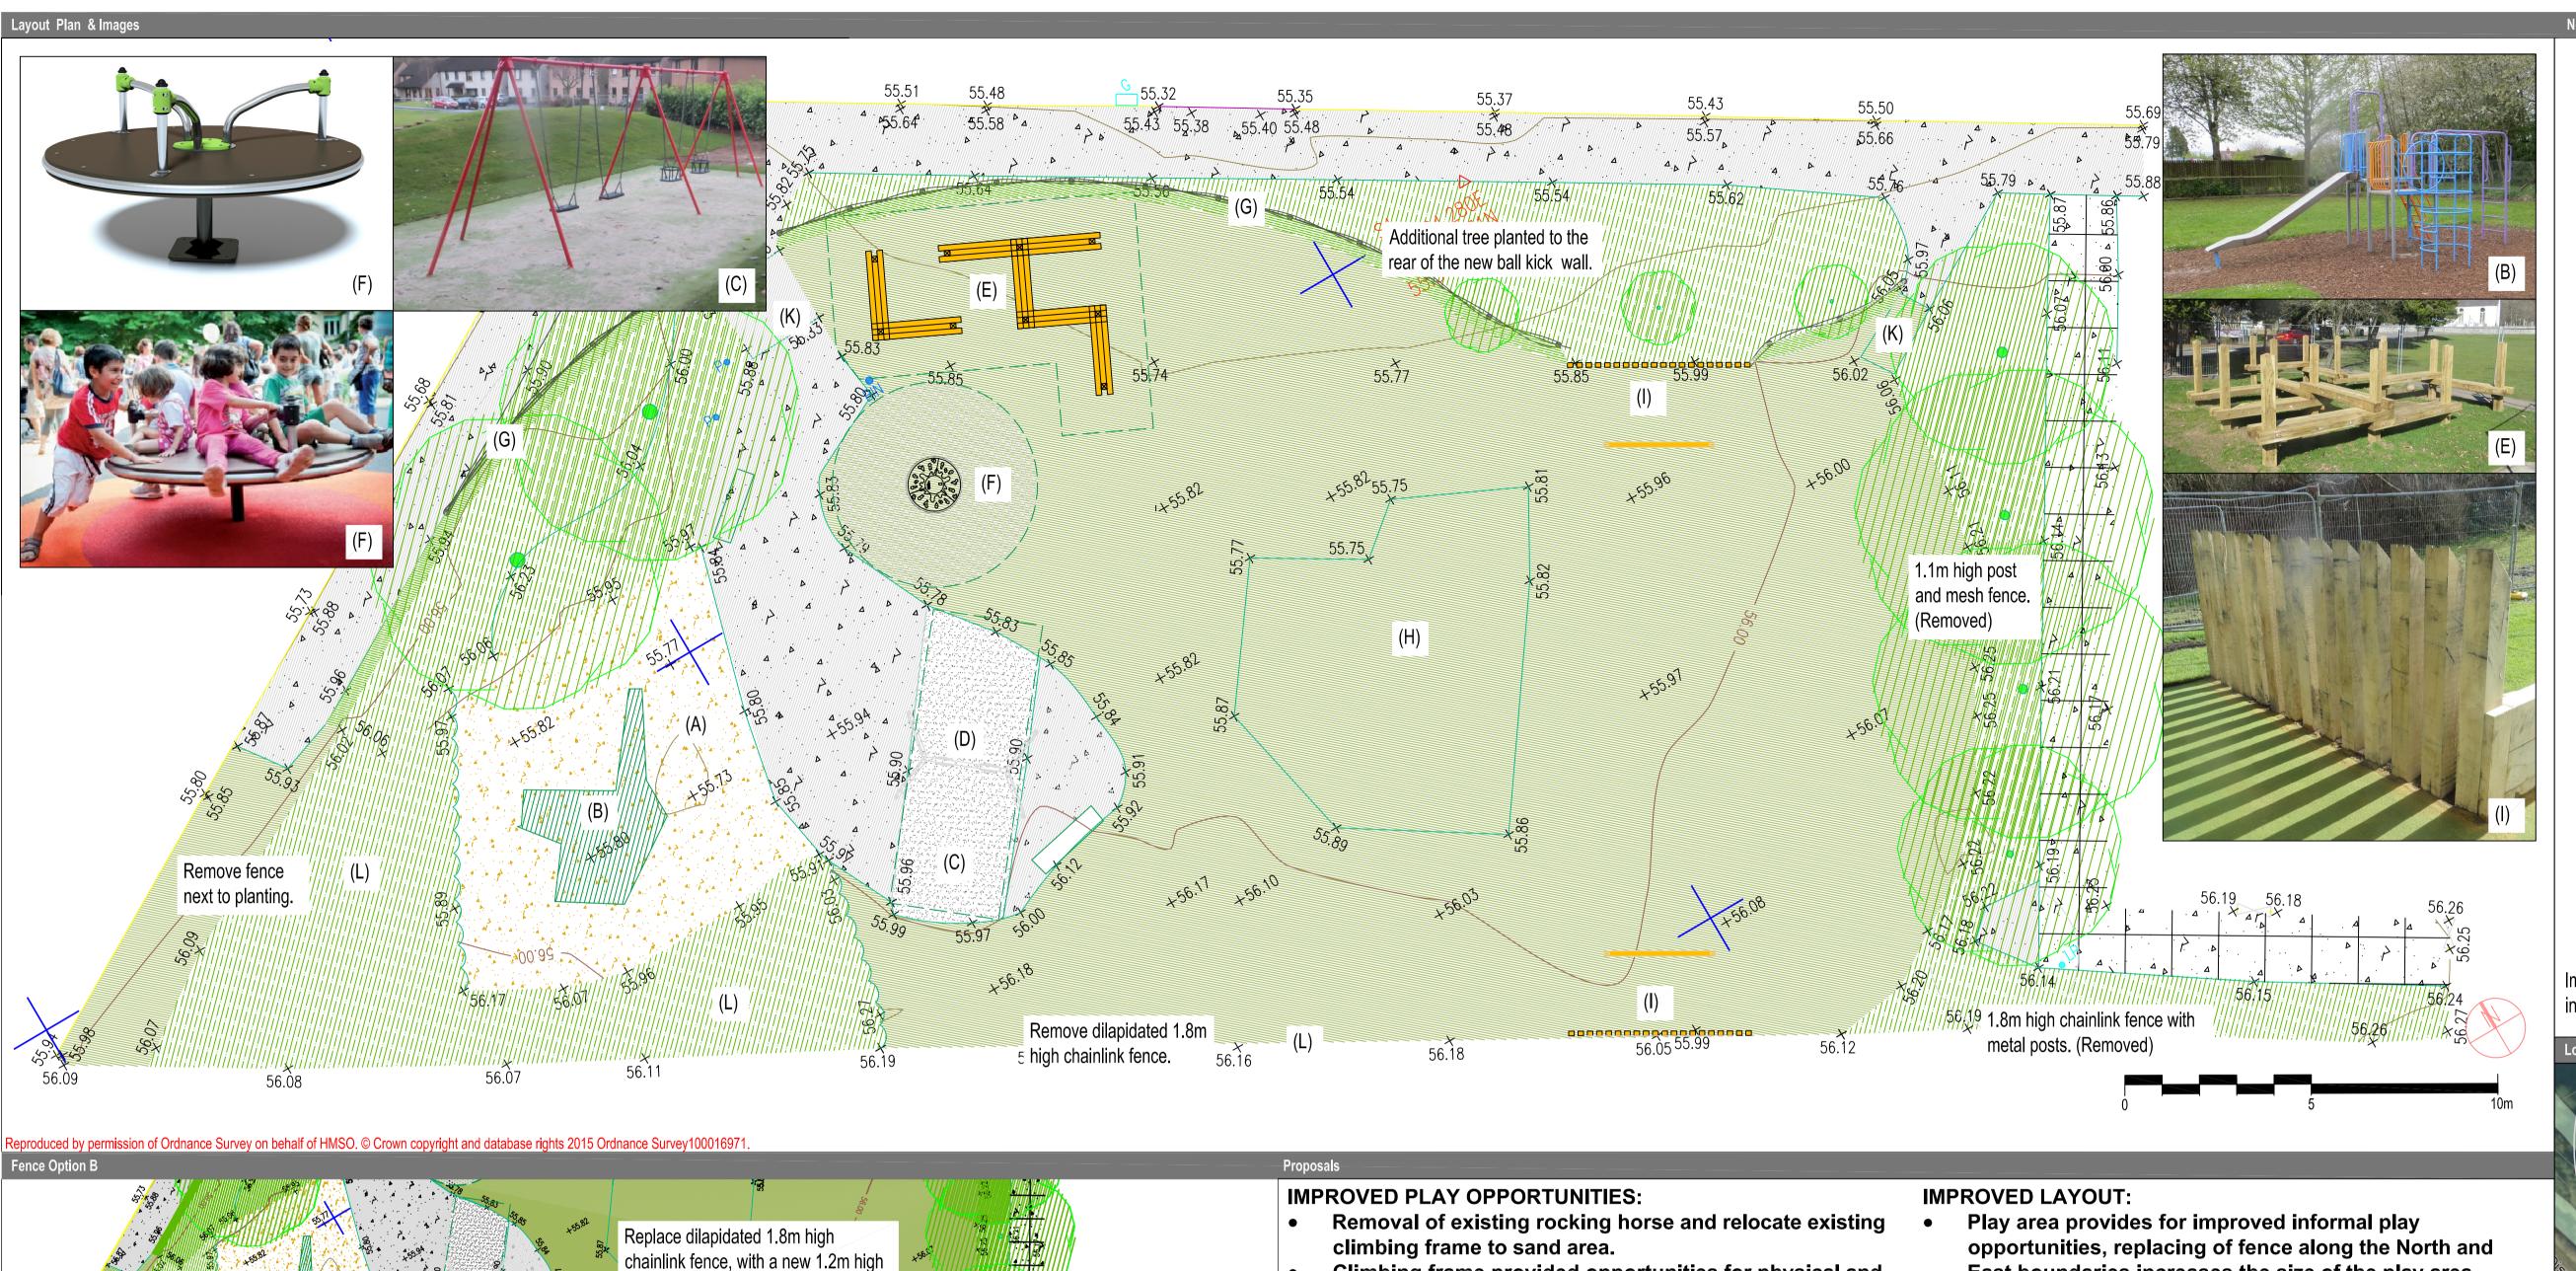
- Replace area of sand with woodchip. including a drainage layer.
- (B) Move existing climbing unit place within woodchip area.
- (C) Sand carpet over existing rubber tiles, Colour Olive green.

- (D) Refurbish existing swing to provide 1 flat seat and 1 cradle and re paint metalwork which is not replaced.
- (E) Informal timber seating structure.

- New roundabout.
- (G) Boundary fence moved to enlarge the play area, created with timber post and 5 wire fence, with mixed species hedge.
- (H) Location of existing multi unit turned back to

- Timber post rebound wall incorporated within the boundary fence. Low level goal set 2m in front of rebound wall to 800mm high x 3000m long.
- Existing dense planting, selective pruning to open up the planting area allowing better visibility and access for informal play.

- (K) Dog grill, removed and paved to match
- Fence Option A- Removal of boundary fence along embankment, allowing easier access to desire routes into woodland area.

- Fence Option B Replace existing fence with a 1.2m high timber post and wire mesh, with 2no stiles located at the desired crossing points.
- (N) Fence Option C Repair existing 1.8m high chainlink fence.

NOTE: There is an existing desire to access the embankment

which has resulted in the existing fence being damaged. Any

repair to the the fence is short lived due to the desire to

access the embankment from the park.
